### Planning Unit – (Module 3)

# CMU HQ - Headquarters

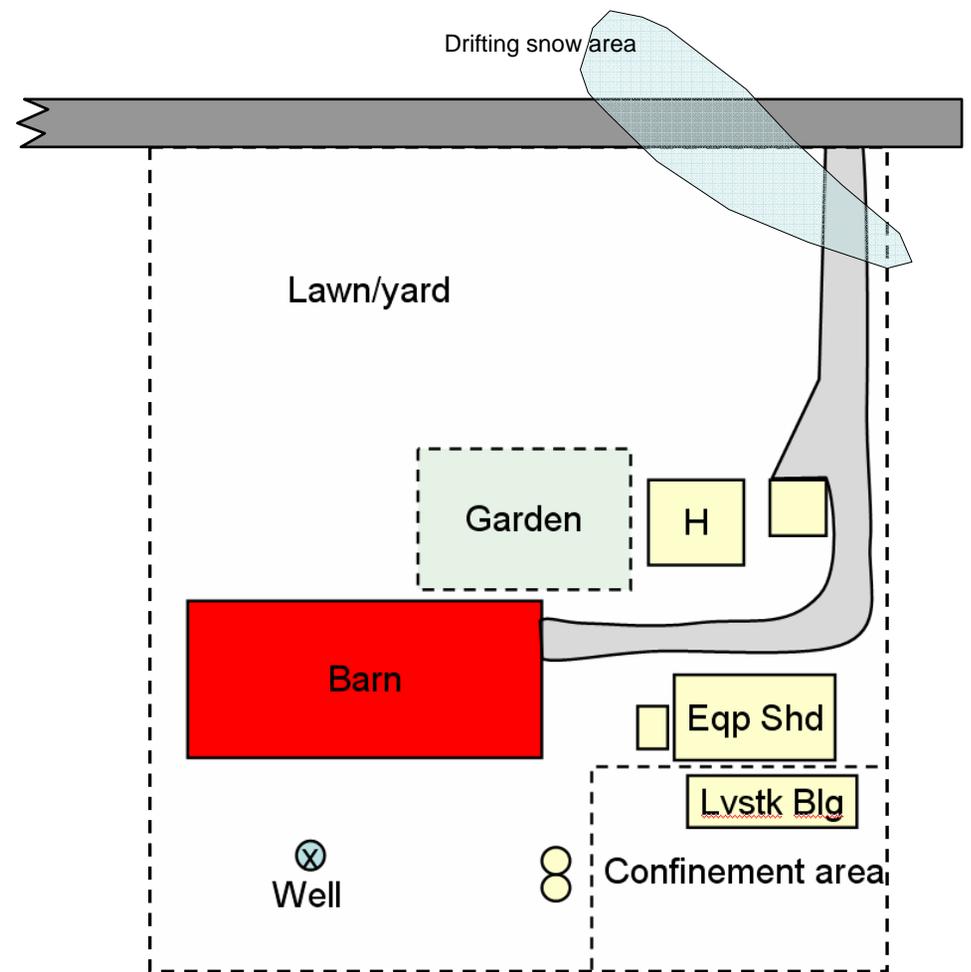
- The unit consists of a house, garage and shop, well, a small barn for hay and silos for grain storage, and a yard and garden. There is a small confined feeding/holding area for beef cattle. Deer frequently damage the few ornamental trees and shrubs around the house. Dust from nearby cropland is common in the spring. During the winter, drifting snow on the county road and driveway and near the house cause access problems. High winter heating bills are common.

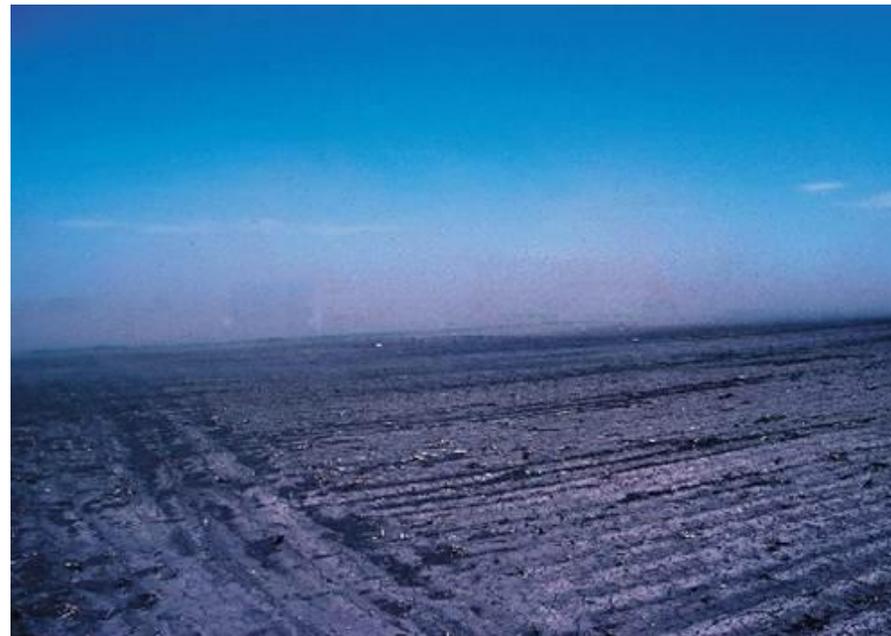
## CMU 1a - Crop

- **Crop seedling establishment (annual crops) is impaired by unsheltered winds from the northwest. Soil is being deposited along the east edge of the field. The Alpha soil is the predominate soil type with slopes that range from 0-2%. No permanent cover is present. Limited fall hunting opportunities. Wind erosion in the field was 10 tons/acre/year. The habitat evaluation worksheet for the crop field resulted in a score of 0.2 for wildlife habitat.**

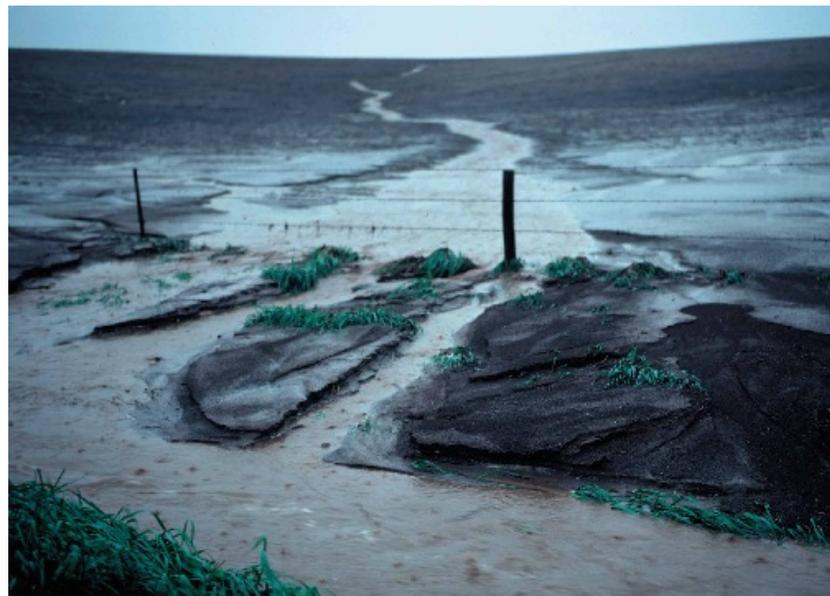
## CMU 1b - Crop

- The Beta soil is the predominate soil type with slopes that range from 3-8%. Cropland soil erosion has created soil deposition along the east fence line. An ephemeral gully was observed at the south end of the unit. No permanent cover is present.

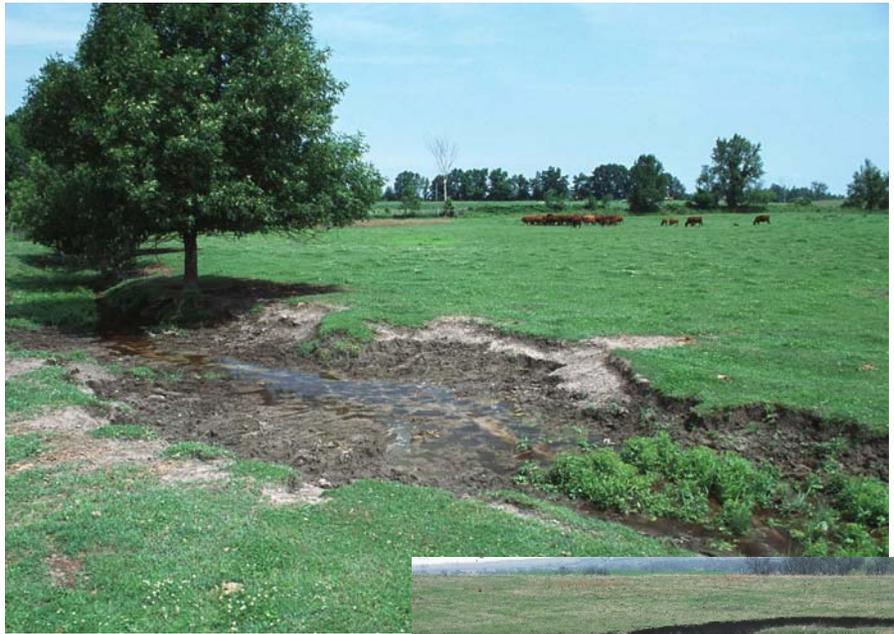
## CMU 2a - Pasture

- Livestock grazing is alternated between the pasture unit (2a) and the naturalized/grazed forest units (2b, 2c). Livestock are confined during the winter and early spring. Livestock are causing stream bank trampling at the south end of the pasture unit and damage to the spring area. Slopes range from 2-8% on soil types Alpha and Beta. Upland bird species were noted along the south end edges of the unit.

Above: Condition of upper intermittent stream.

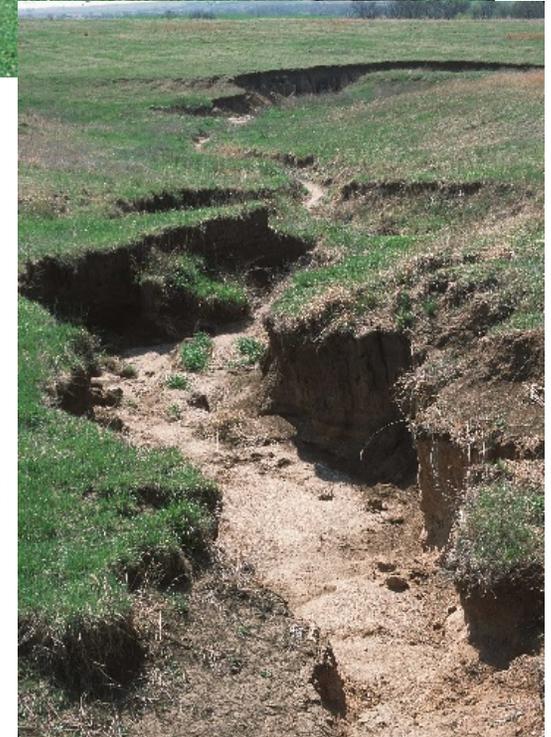
Right: Condition of lower intermittent stream just above the confluence with the spring-fed reach.

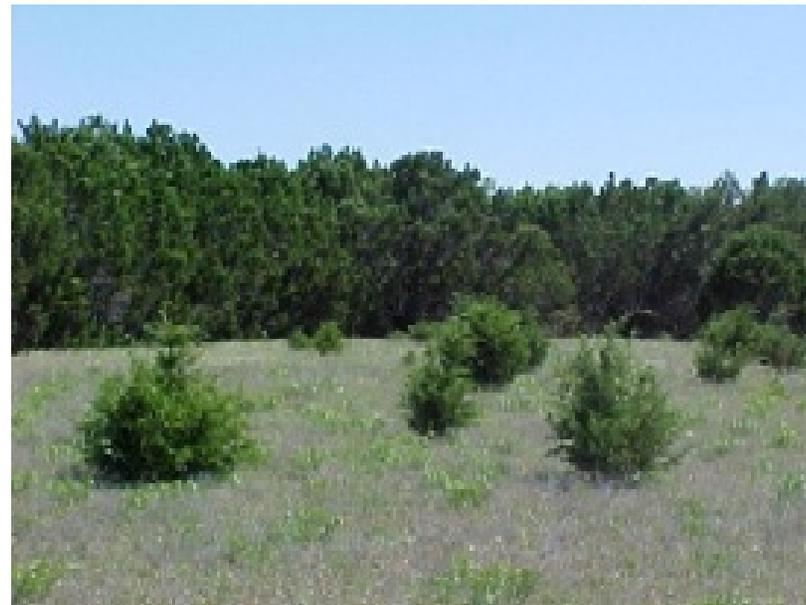
## CMU 2b – Native Pasture

- Livestock grazing is alternated between this unit, the pasture unit (2a), and grazed forest unit (2c). Livestock is confined during the winter and early spring. Soil type Alpha has 0-2% slopes. Scattered conifers are present. Arrow head chips can be found along the road cut at the south-east end of the unit.

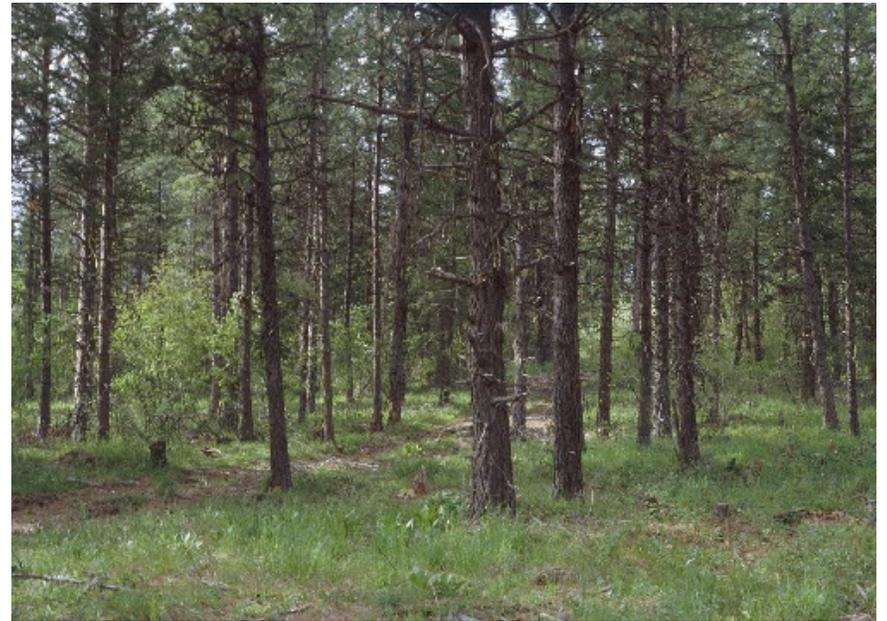
## CMU 2c – Grazed Forest

- The Beta soil predominates on the unit with slopes ranging from 8-15%. Unrestricted livestock access throughout the entire unit.
- A naturally-established, even-aged stand of conifers occupy the northern area of the unit and range from 12-18" diameters-at-breast-height (DBH). There are scattered openings of herbaceous vegetation/forage; canopy shading has reduced forage production under the trees. Snags are scattered throughout the area.
- The south end consists of upland mixed "high quality" hardwoods adjacent to the spring-fed stream with slopes ranging from 15-25%. The hardwoods range from 6-14" DBH and are uneven-aged mast-producing trees. The area has evidence of livestock trampling and compaction including the stream area. Also, tree regeneration and understory vegetation densities are low. Lower than optimum wildlife numbers are also present.

View from road at the northern tip of unit looking south.

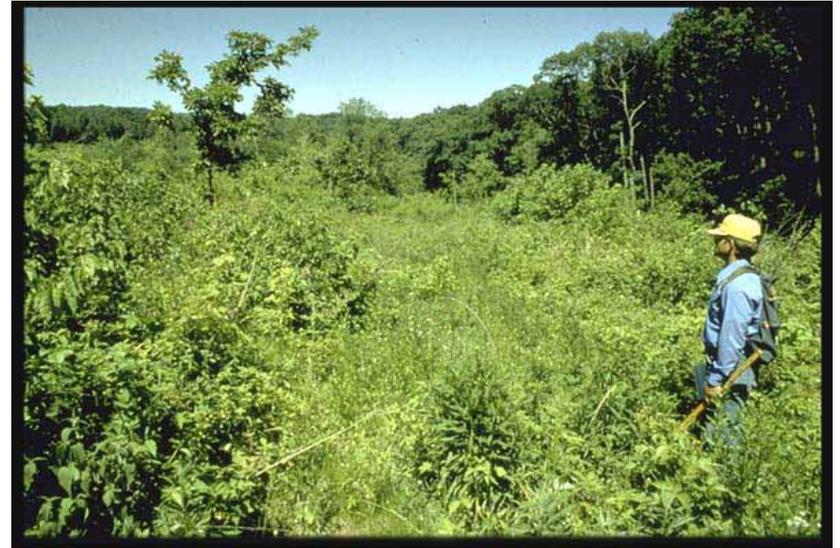
## CMU 3 – Forest

- **Shade-intolerant 4-8” dbh conifers occupy east facing steep slopes (25-40%). The area has extensive mortality from bark beetles and tree competition creating slash and debris that pose a significant wildfire risk. “High-graded” bottomland hardwoods occupy 0-2% along Noname Creek. The stream crossing consists of an old, undersized culvert that has been damaged by flooding and is acting as a barrier to fish movement. Tree removal from riparian areas has reduced shade and increased stream water temperatures. Stream banks are eroding in several spots. These conditions have decreased suitable trout habitat and populations have declined. East and upslope of Noname creek, the slopes range from 10-20%. All merchantable conifers and hardwoods were harvested 5 years ago. The site is now occupied with herbaceous, shrub and undesirable hardwood tree species. Roads and skid trails have numerous areas of excessive erosion partially caused by trespass of 4WD vehicles.**

East and upslope of Noname Creek.
